| | Washington State<br>Department of<br>Transportation<br><br>I-405, Brickyard to SR 527<br>Improvement Project<br>Contract No. 009727 | Doc Type: RFI |

| Submittal: BY-CRE-01613_009727_RFI_00265_16.03.02_MSE Wall 23.80R Settlement and Plumbness | |

I-405  
BRICKYARD TO SR527  
IMPROVEMENT PROJECT

| GROUND IMPROVEMENTS AT WALL 23.80<br>11+50 - 14+50 | Hz Scale<br>1:20 |

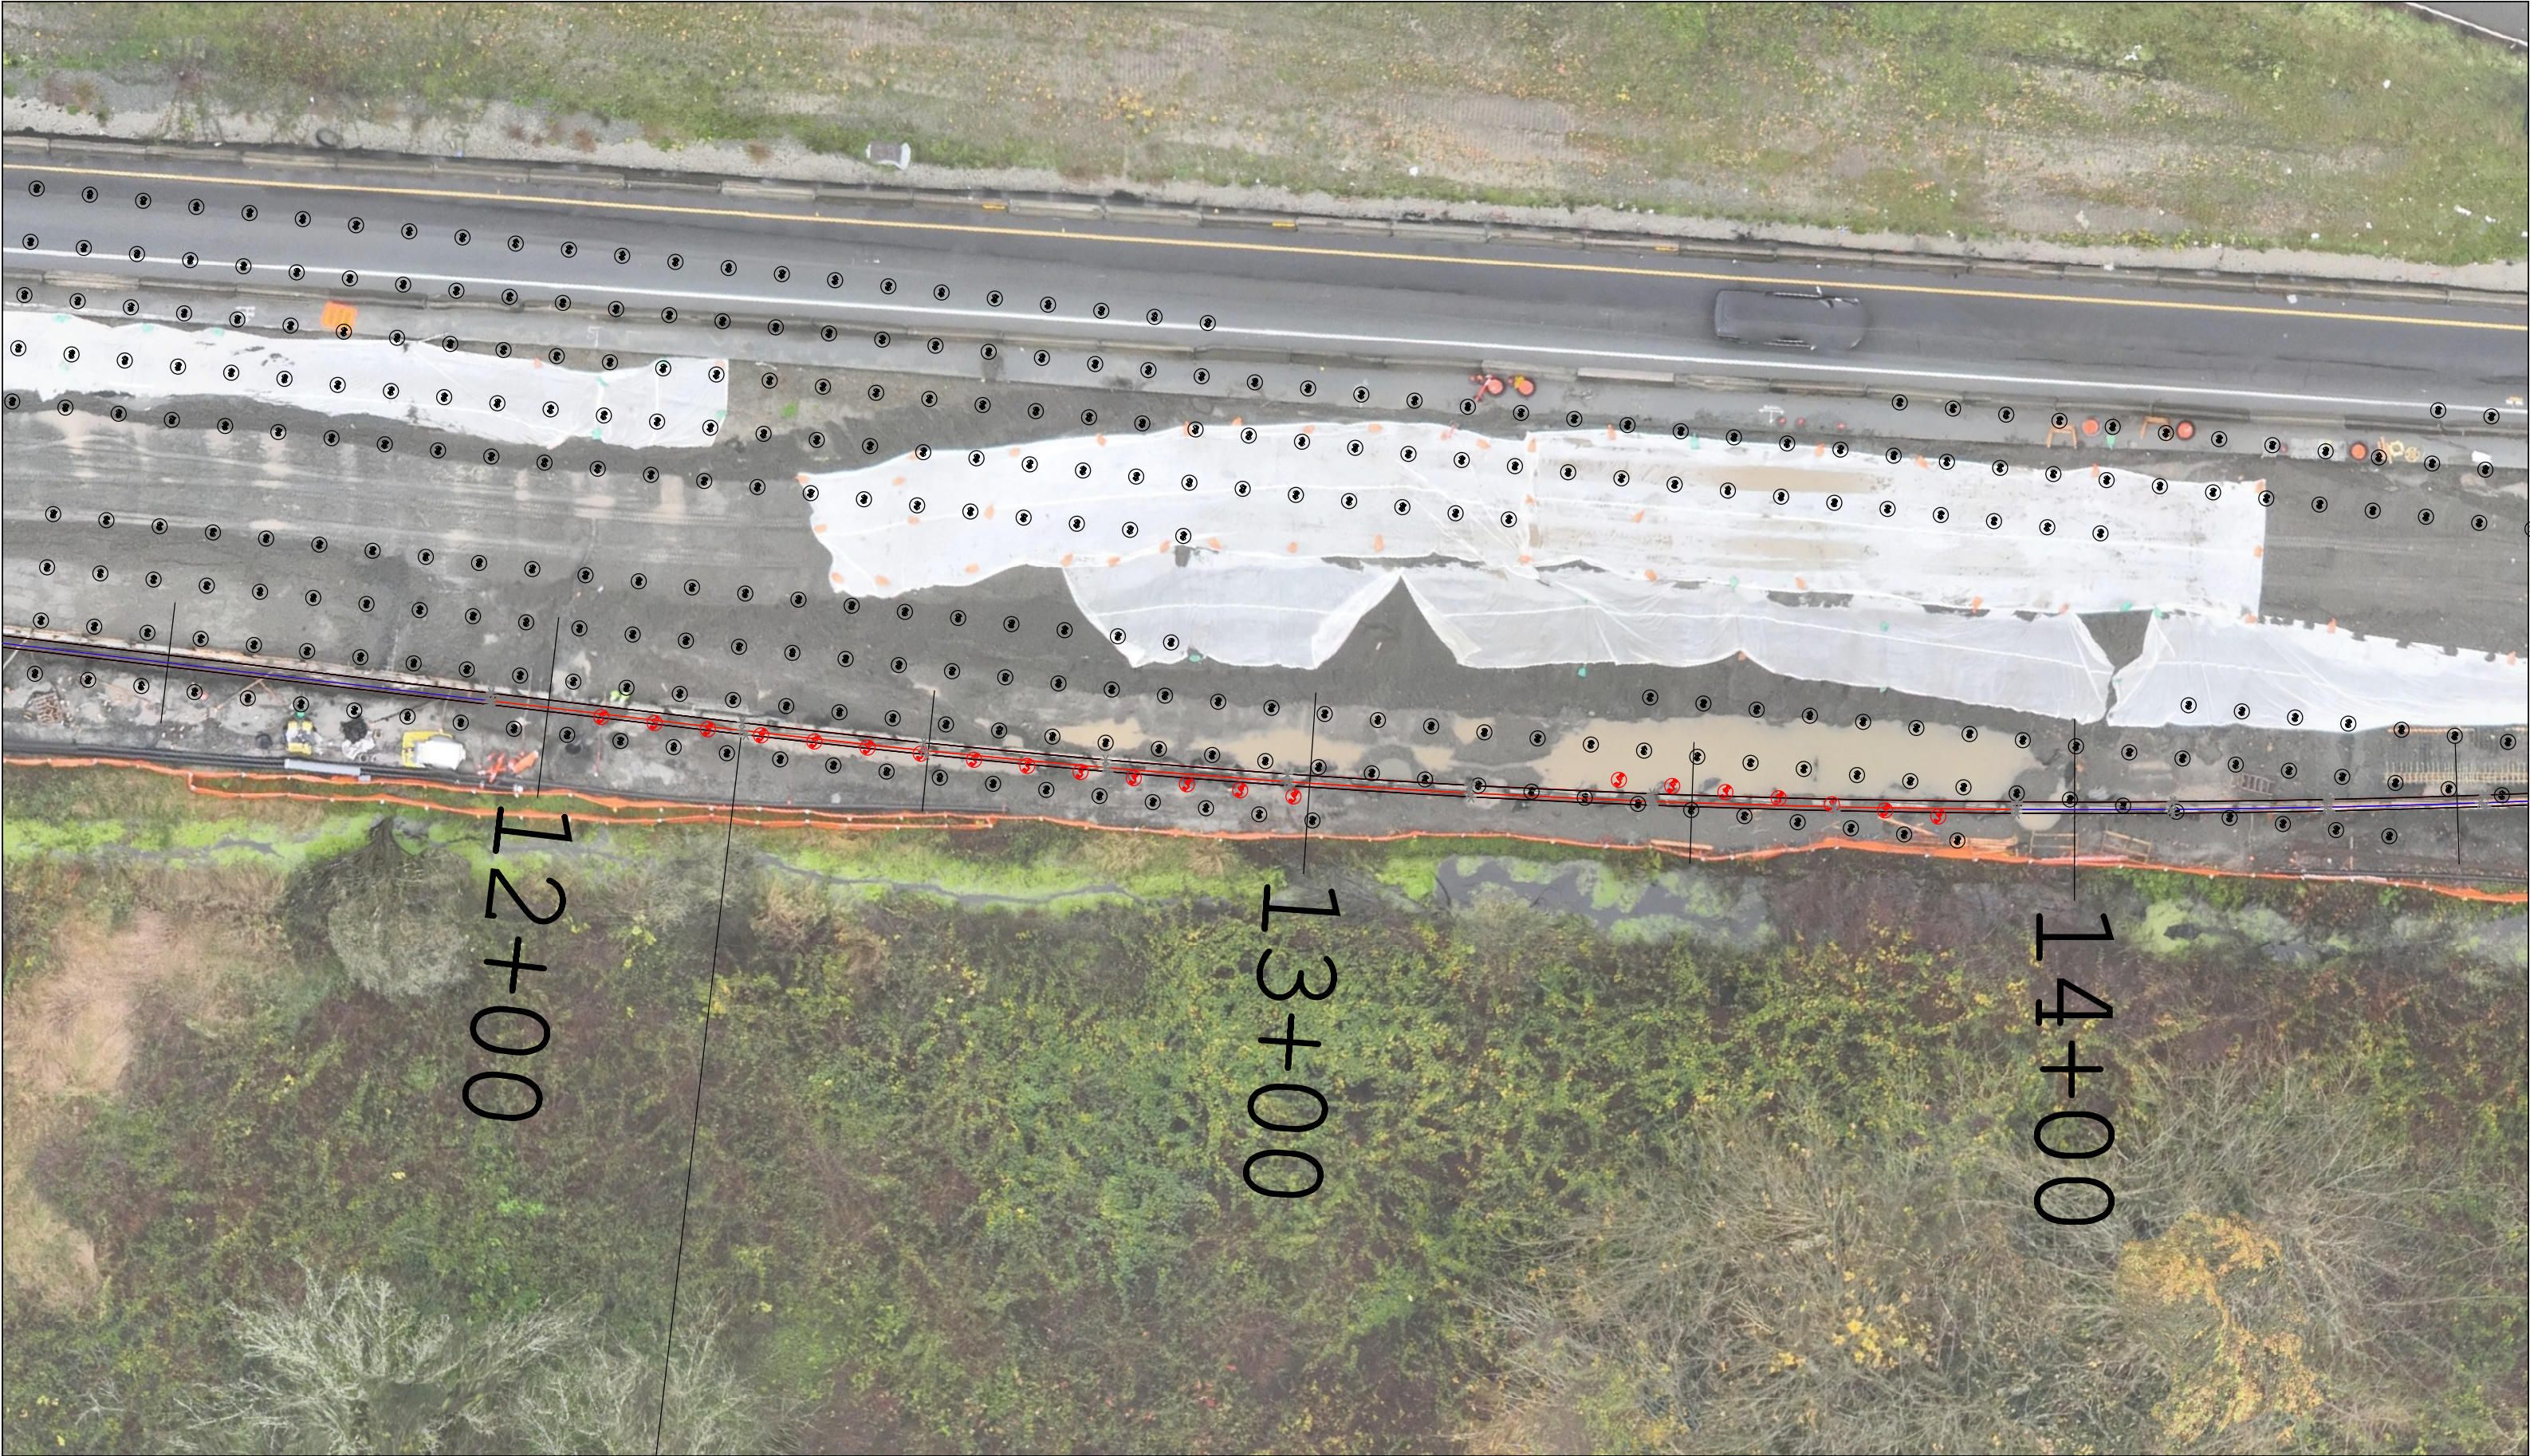
On 10/31/24, Skanska observed that the MSE wall facing panels installed on Wall 23.80R from approximately STA 12+00 to 15+00 had positive batter in excess of 5 inches at the top of panels. On 11/6/24, Skanska began removing backfill and MSE panels for reinstallation to achieve the required plumbness and wall line. On 11/7/24, one day after resetting a portion of the MSE panels and beginning the backfill operation in accordance with the wall designer's installation manual, Skanska observed panels that had been reset had gained 1"-2" of positive batter overnight.

Upon further investigation, Skanska confirmed that the leveling pad at wall STA 12+00, STA 12+50 and STA 13+00 has settled 0.01 feet, 0.13 feet, and 0.25 feet respectively. The observed settlement exceeds the estimated settlement listed within the geotech report Table 6.34; however, is within the allowable settlement.

Based on survey results provided by Skanska, it appears that the reinforced concrete leveling pad is settling more or less vertically (with minimal rotation of the leveling pad). Those areas appear to line up fairly well with zones where the leveling pad spans across from one row of stone columns to another (i.e. the layout of the stone columns was on a square grid and did not follow the path of the wall's leveling pad). The soil beneath the existing leveling pad may be soft enough to be settling beneath the load of the MSE wall panels. The issue appears to be concentrated underneath the deepest portion of the leveling pad from Wall Station 11+95.007 to 13+90.007 where the top of the 12" thick leveling pad is called out at elevation +22.40'.

We recommend removing the existing wall and leveling pad within the station range noted above plus a short zone to the north of station 13+90.007 and a short zone to the south of station 11+95.007 as described in greater detail below. We recommend that an over excavation and replacement of the unsuitable subgrade be performed to a depth of 3 feet below the bottom of the proposed new concrete leveling pad. We recommend that this over excavation (at 3' below the bottom of the proposed new concrete leveling pad) should extend at that elevation at least between wall station 11+92.007 and 13+93.007. We recommend that the ends of the over excavated trench can then be sloped up from there to existing wall footing grade at a slope no steeper than 1H:1V to help ease the transition between the deepest portion of the leveling pad (i.e. top of leveling pad elevation +22.40') and the portions to the south and north of it where the leveling pad is planned at a higher elevation. We recommend that the over excavated trench below the leveling pad be a minimum of 6' wide and extend horizontally at least 2' from the planned wall panel face toward the east (i.e. toward the existing creek) and extend horizontally at least 4' from the planned wall panel face toward the west (i.e. toward the reinforced backfill zone under the roadway).

We recommend that one of two options (or a combination of both) be utilized to backfill the over excavated area.

**Option 1:** Place a layer of Mirafi 160N geotextile separation fabric (or equivalent) down in the over excavated trench and backfill over the top of it with 12" of compacted Gravel Borrow (9-03.14(1)) or Gravel Borrow for Structural Earth Wall (9-03.14(4)) compacted in accordance with WSDOT Standard Specifications 2-03.3(14)C - Method B. Place a layer of Tensar BX1500 geogrid on top of the first 12" thick compacted layer of gravel and place a second 12" thick layer of compacted Gravel Borrow (9-03.14(1)) or Gravel Borrow for Structural Earth Wall (9-03.14(4)) compacted in accordance with WSDOT Standard Specifications 2-03.3(14)C - Method B. Place a second layer of Tensar BX1500 geogrid on top of the second 12" thick compacted layer of gravel and then place a third and final 12" thick layer of compacted Gravel Borrow (9-03.14(1)) or Gravel Borrow for Structural Earth Wall (9-03.14(4)) compacted in accordance with WSDOT Standard Specifications 2-03.3(14)C - Method B. Either a reinforced concrete leveling pad (in accordance with the existing wall plans) or an unreinforced concrete leveling pad (in accordance with the pre-approved plans for SSL walls described in the WSDOT GDM Chapter 15, Appendix 15-N), can be constructed on top of the backfill section described above.

**Option 2:** Backfill the trench with unreinforced controlled density fill (cdf). Either a reinforced concrete leveling pad (in accordance with the existing wall plans) or an unreinforced concrete leveling pad (in accordance with the pre-approved plans for SSL walls described in the WSDOT GDM Chapter 15, Appendix 15-N), can be constructed on top of the backfill section described above.
