NW-12 Vault

Thursday, July 24, 2025 3:03 PM

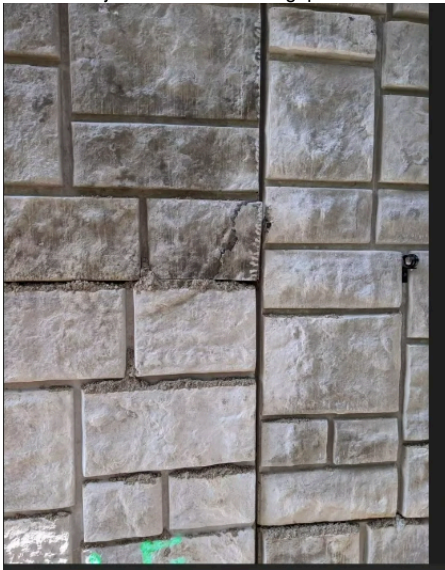
- Spalls on the corners
 - No rebars exposed
 - Result of the binding
 - Look in the joint - don't have the gap maintained

- Zach think this looks like the panel hit the one next to it and created that spall
- Repair resolution
 - Fine to patch
 - BUT if there is insufficient gap - need to trim or sawcut?

- Trim or maintain the gap (should be 3/4")
 - Ensure that post construction settlement won't cause a further spall
 - Sawcut or grind
 - Doesn't meet 1/2" gap - trim

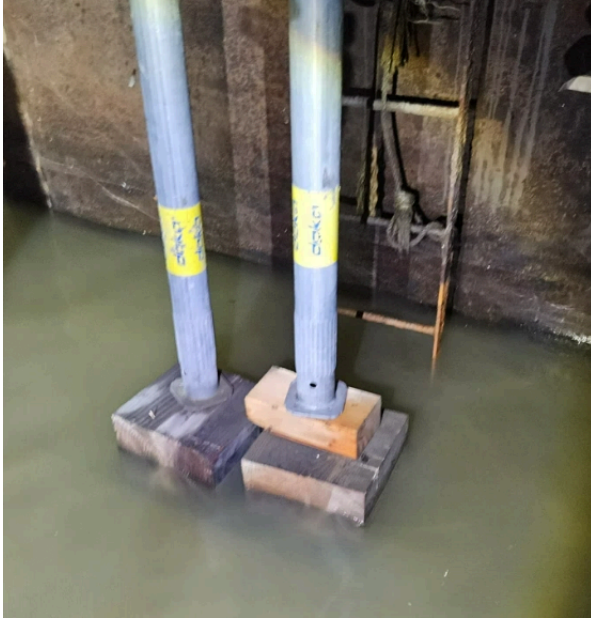
- 6500 psi
- Mohammad S. - not sure why we would allow them to test the concrete and use that strength (concrete gets stronger over time)
- Mohamad A. - not concerned with the concrete strength - concerned with the jacks - takes back the comment - cannot use one sample for the entire vault (300')
 - Can buy 3-4 ksi concrete
- Modelling middle pole brace as a 6" thick wall
- Design the middle wall
 - Then backing it out to get the post size
- Posts
 - Only taking live load and dead load from the pavement
 - Mohamad A. - he can buy that - dead load of the structure is already at the sides
 - Takes no issue with that
 - Concern goes back to the posts

- - Greg - agree this is a concern - that is why they are being inspected weekly to start
 - Don't have anything from the manufacturer saying that these are intended for use in this kind of location, for this kind of loading, for this kind of duration
 - Internet search - not used for anything like this
 - THEY NEED TO BE AWARE - IF THERE ARE ISSUES - WE WILL SHUT THEM DOWN
 - Mohammad A.
 - Asbuilt condition of the box - why using pinned connection - haunches usually indicate a pinned condition
 - If that is a fixed connection - someone buys off on the reinforcing that they say it is
 - What happens if we model it without the supports to see if they are needed
 - Don't care about HL-93 - but care about legal loads
 - Other loads can be managed

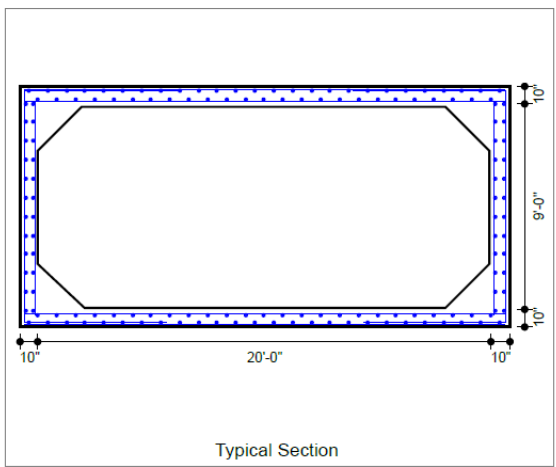
◦ First load rating

- Parallel should be perpendicular
- Soil Density looks low - usually low is 130 pcf
- Go back to normal
 - Rerun it that way to see where numbers are at
 - Perpendicular and not parallel
 - If close enough to 1 for all legal loads
 - If there is a traffic barrier - needs to be accounted for in the loading 600 lb/LF

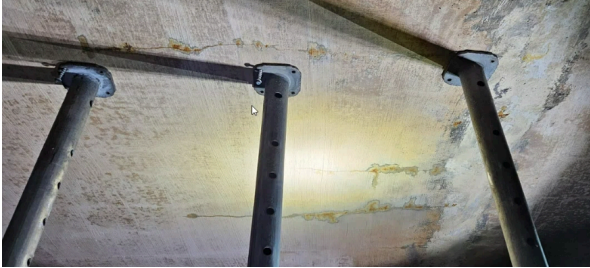
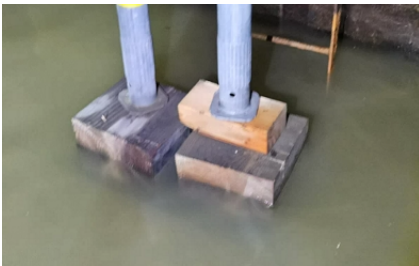
This is not proper installation of these
