Fish Passage & Diversion Screening Inventory Database Report Cover Sheet

Level A Culvert Assessment Report

Site ID: 102 N128	Stream: SF Perry Cr	WRIA: 08.0070	
Latitude: 47.79148	Tributary To: North Cr	Fish Use Potential: Yes	
Longitude: -122.20685

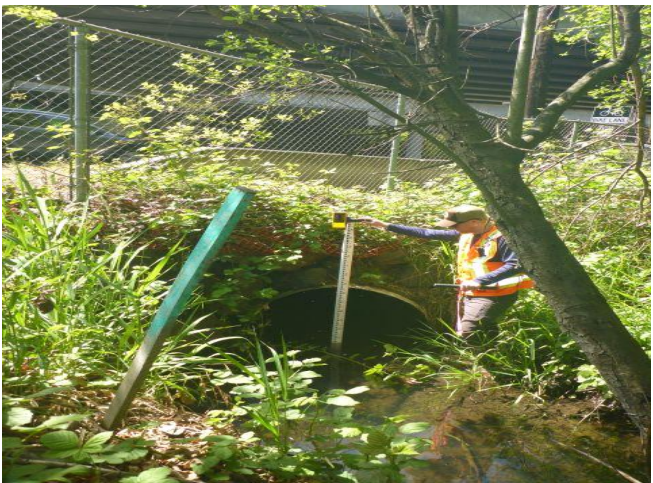
Culvert Details							Level A Parameters						
ID	Shape	Material	Span	Rise	Length	WDIC	Apron	WSDrop	Location	Countersunk	Backwater	Slope (%)	Sediment
1.1	RND	OTH	1.22	1.22	80.50	0.27	US	0.00		Yes	No	0.23

Channel Description	
Toe Width (m):	1.3
Average Width (m):	1.45
Culvert/Stream Width Ratio:	0.84
Plunge Pool	
Length (m):	-999.99
Max Depth (m):	0.00
OHW Width (m):	0.00
Road	
Fill Depth (m):	2.50

Assessment Results			
Tidal Influence:	No	Tidegate Present:	No
Barrier:	No	Passability (%):	100
Reason:	N/A	Fishway Present:	No
		Method:	Level A
		Recheck:

Comments
 Inlet=CST; outlet=CAL (same span&rise). 2m DS of outlet is RND PVC pipe entering creek. Didn't measure BFW US of culvert because channel splits US of inlet. Inlet appeared to be CST but outlet was CAL. Inlet: 47.79103,-122.20769.
