“NOT-LOW” OPINION PAPER FOR I-405 MP 24.4, SAMMAMISH RIVER CHANNEL MIGRATION ZONE

PURPOSE:

The purpose of this opinion paper is to assess the channel migration potential of the Sammamish River within the vicinity of I-405 near MP 24.4. The Washington State Department of Transportation (WSDOT) Hydraulics Manual section 7-2.5.4 states that all water crossing structures should assess past and potential future channel migration. If a channel is expected to migrate, further analyses will be the responsibility of the Design-Builder during final design.

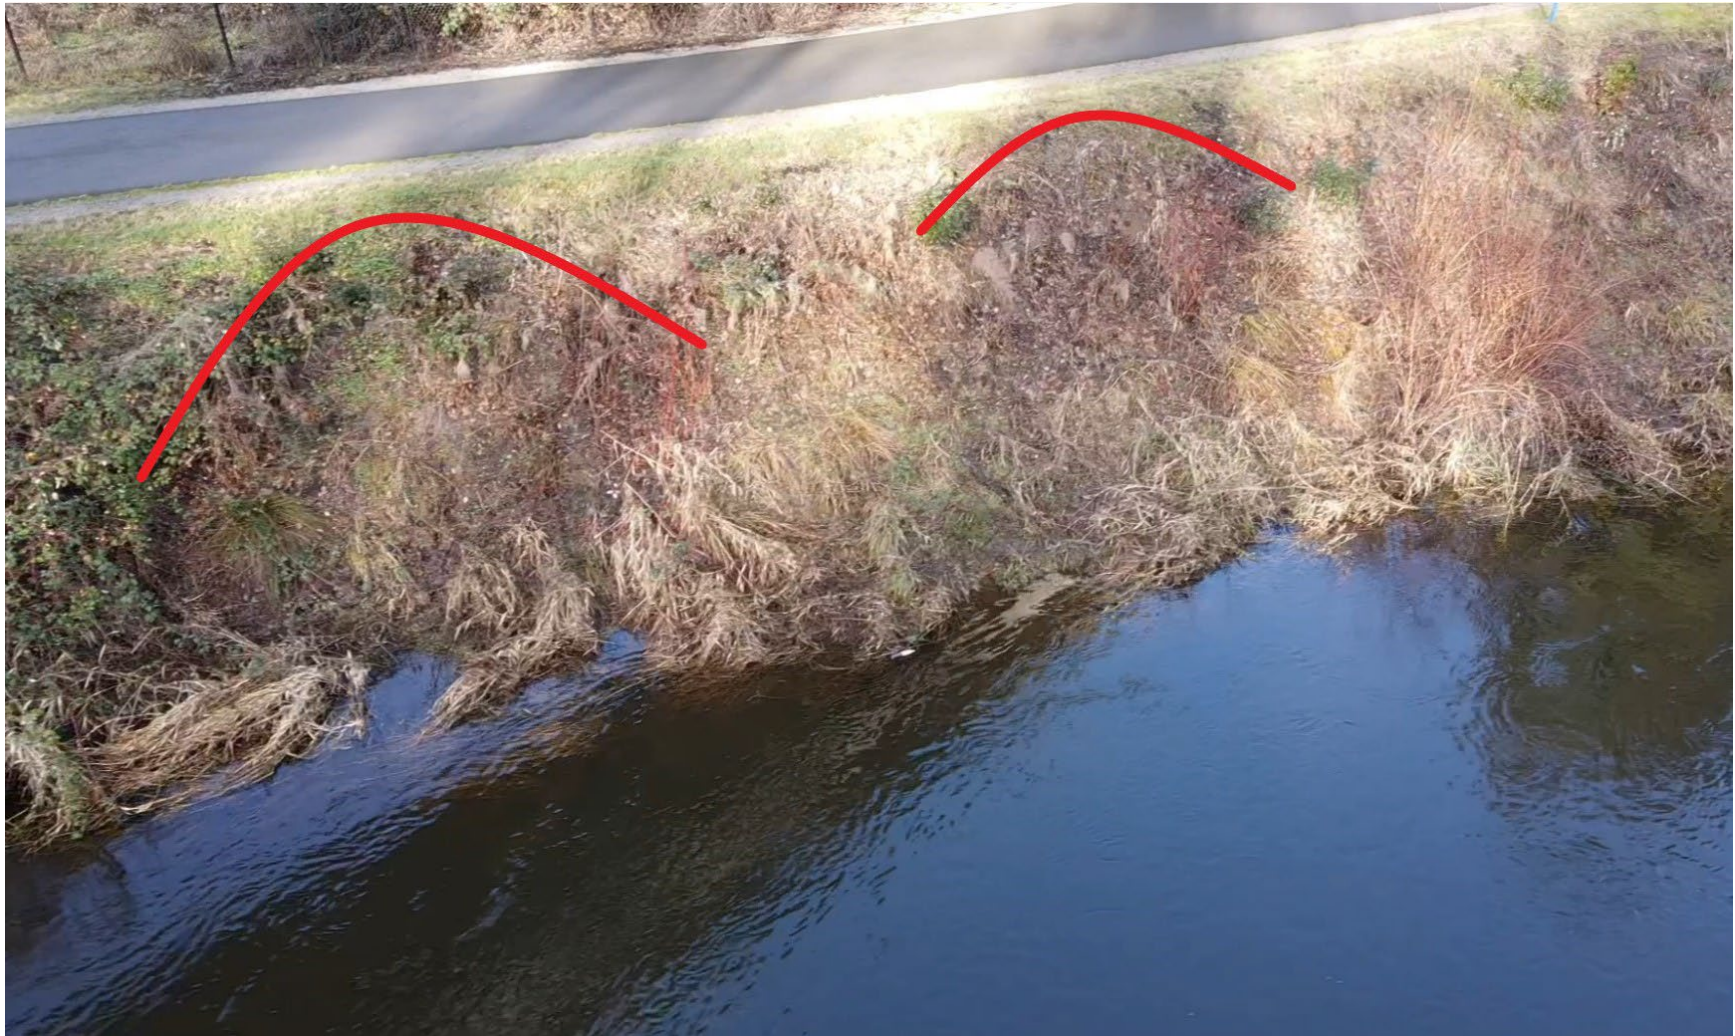
Figure 3. Photo of north bank sloughing at 20 feet and 60 feet north of the existing NB I-405 to WB SR 522 bridge crossing (western end of the King County repairs) taken during January 1, 2023 site visit. The red lines highlight the top of impacted bank slope.

WSDOT completed a site recon of the site on January 1, 2023. During the site recon, they observed that the north bank near of the existing ramp appeared to consist of fine granular soils that are likely unstable at the current slope and that the bank was possibly sloughing into the river where it had previously been repaired. Figure 3 shows two locations where sloughing was observed just east of the Northbound I-405 to the eastbound SR 522 bridge crossing. No attempt was made to remove vegetation that limited the view of bank or river, but **Figures 4 and 5** show that the channel has changed from the original uniform trapezoidal shape and alignment of the USACE constructed channel. Long term scour is evident at the existing bridge columns along the north bank. An old corrugated metal pipe (**Figure 6**) projects beyond the south river bank just east of the northbound I-405 to eastbound SR 522 bridge crossing. Since this pipe outlet was likely constructed to match the channel bank, the current condition suggests that the south bank is also eroding or sloughing.

The risk of channel migration within the vicinity of I-405 MP 24.4 is NOT LOW and therefore will require further analysis during final design as part of the Hydraulic Design Report for this water crossing.

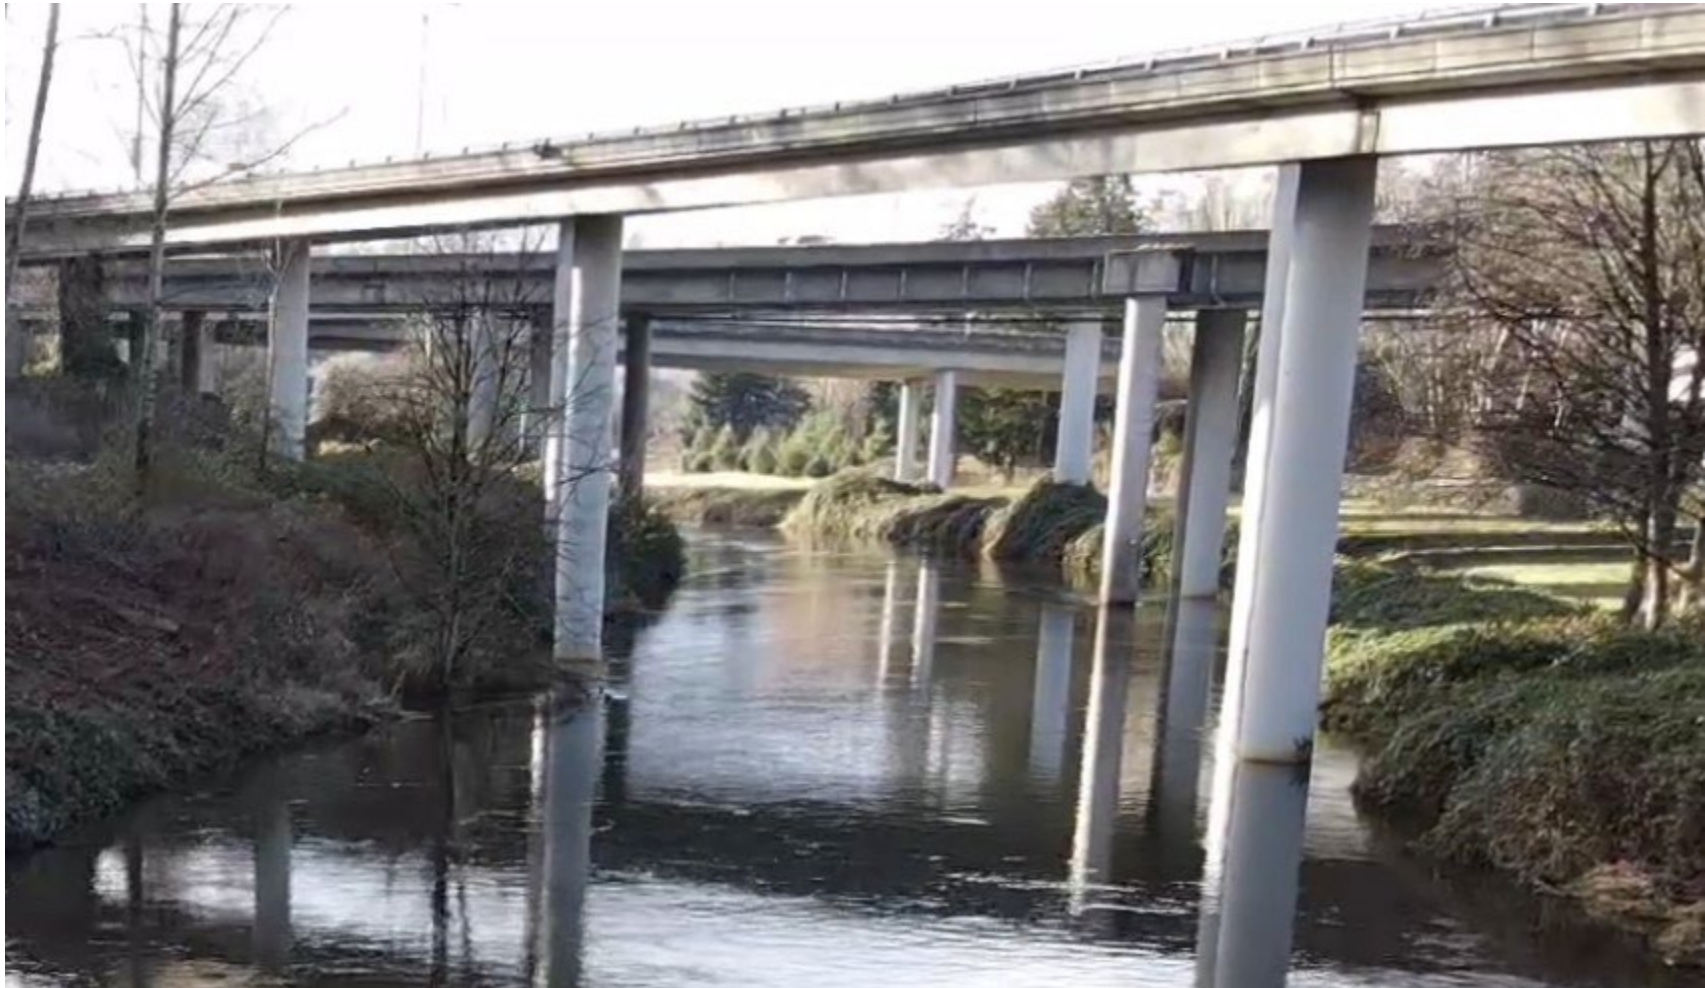
Figure 4. Photo of the Sammamish River looking west through the crossings. Note the right bank scour around the existing NB I-405 to WB SR 522 bridge column in the foreground (January 1, 2023 site visit).

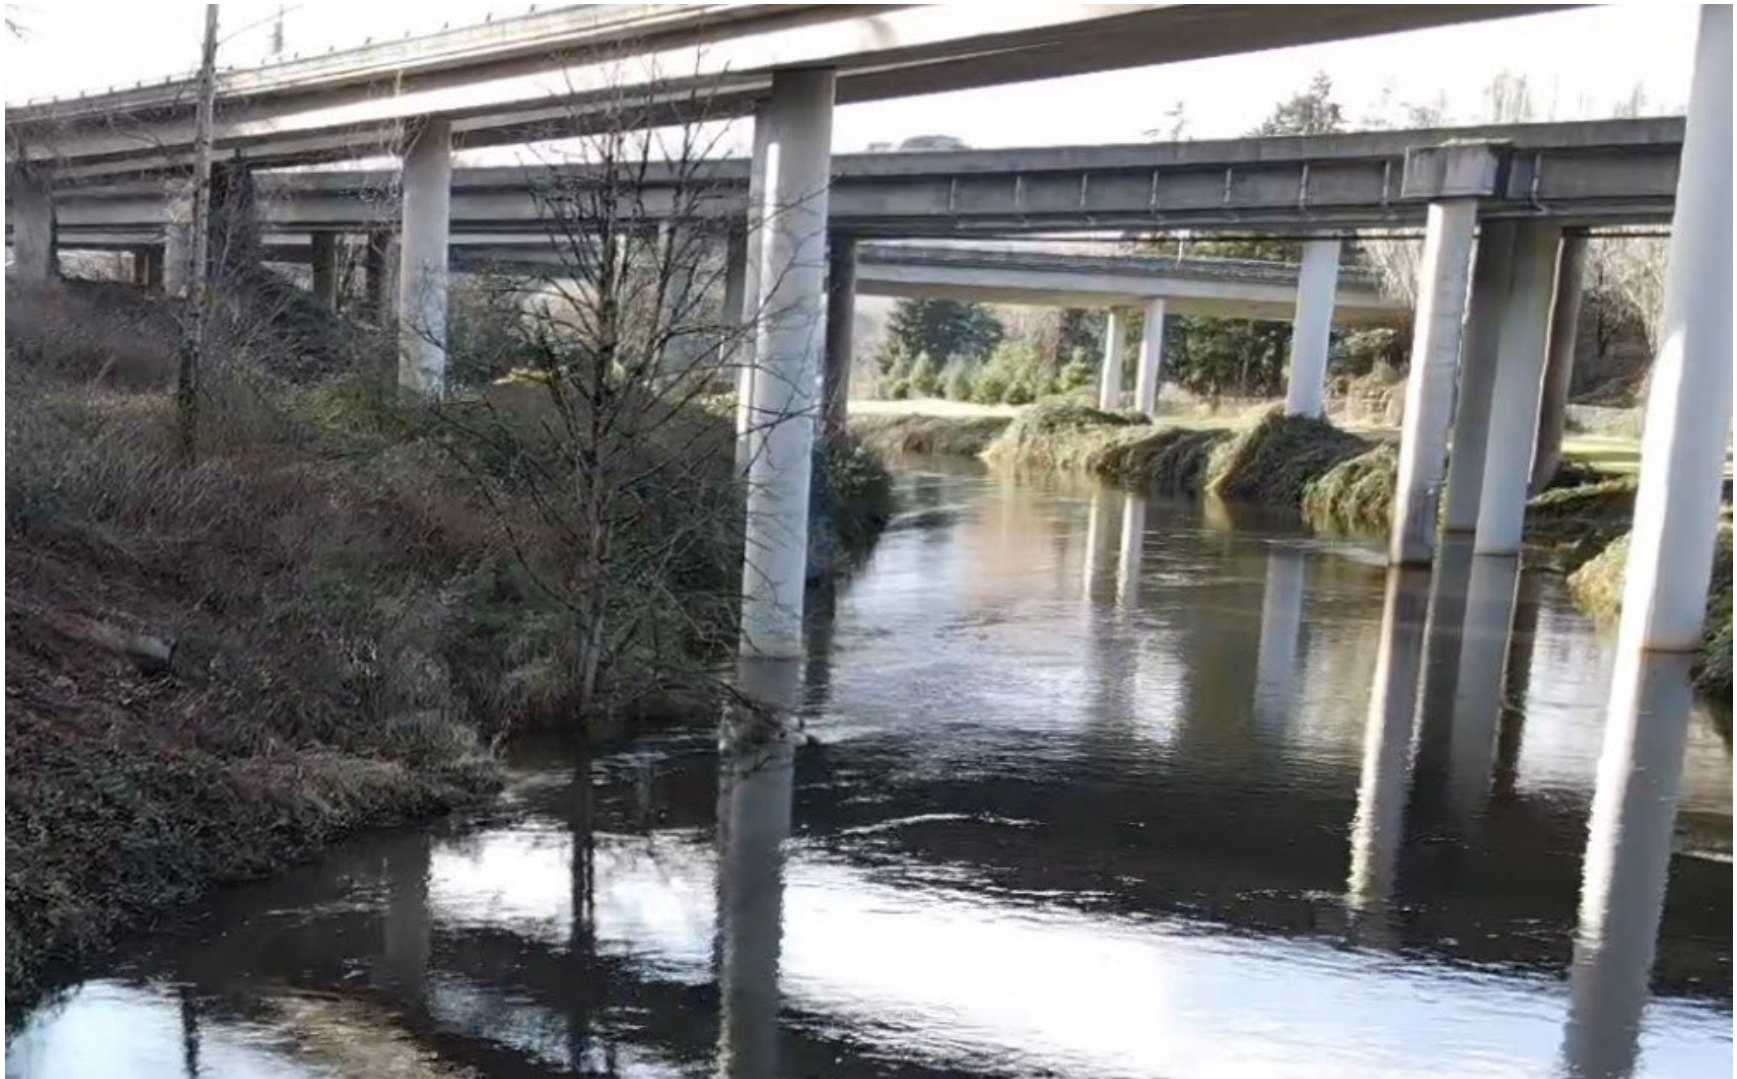
Figure 5. Photo of the Sammamish River looking west through the crossings. Note the right bank scour around the existing NB I-405 mainline bridge columns (January 1, 2023 site visit).

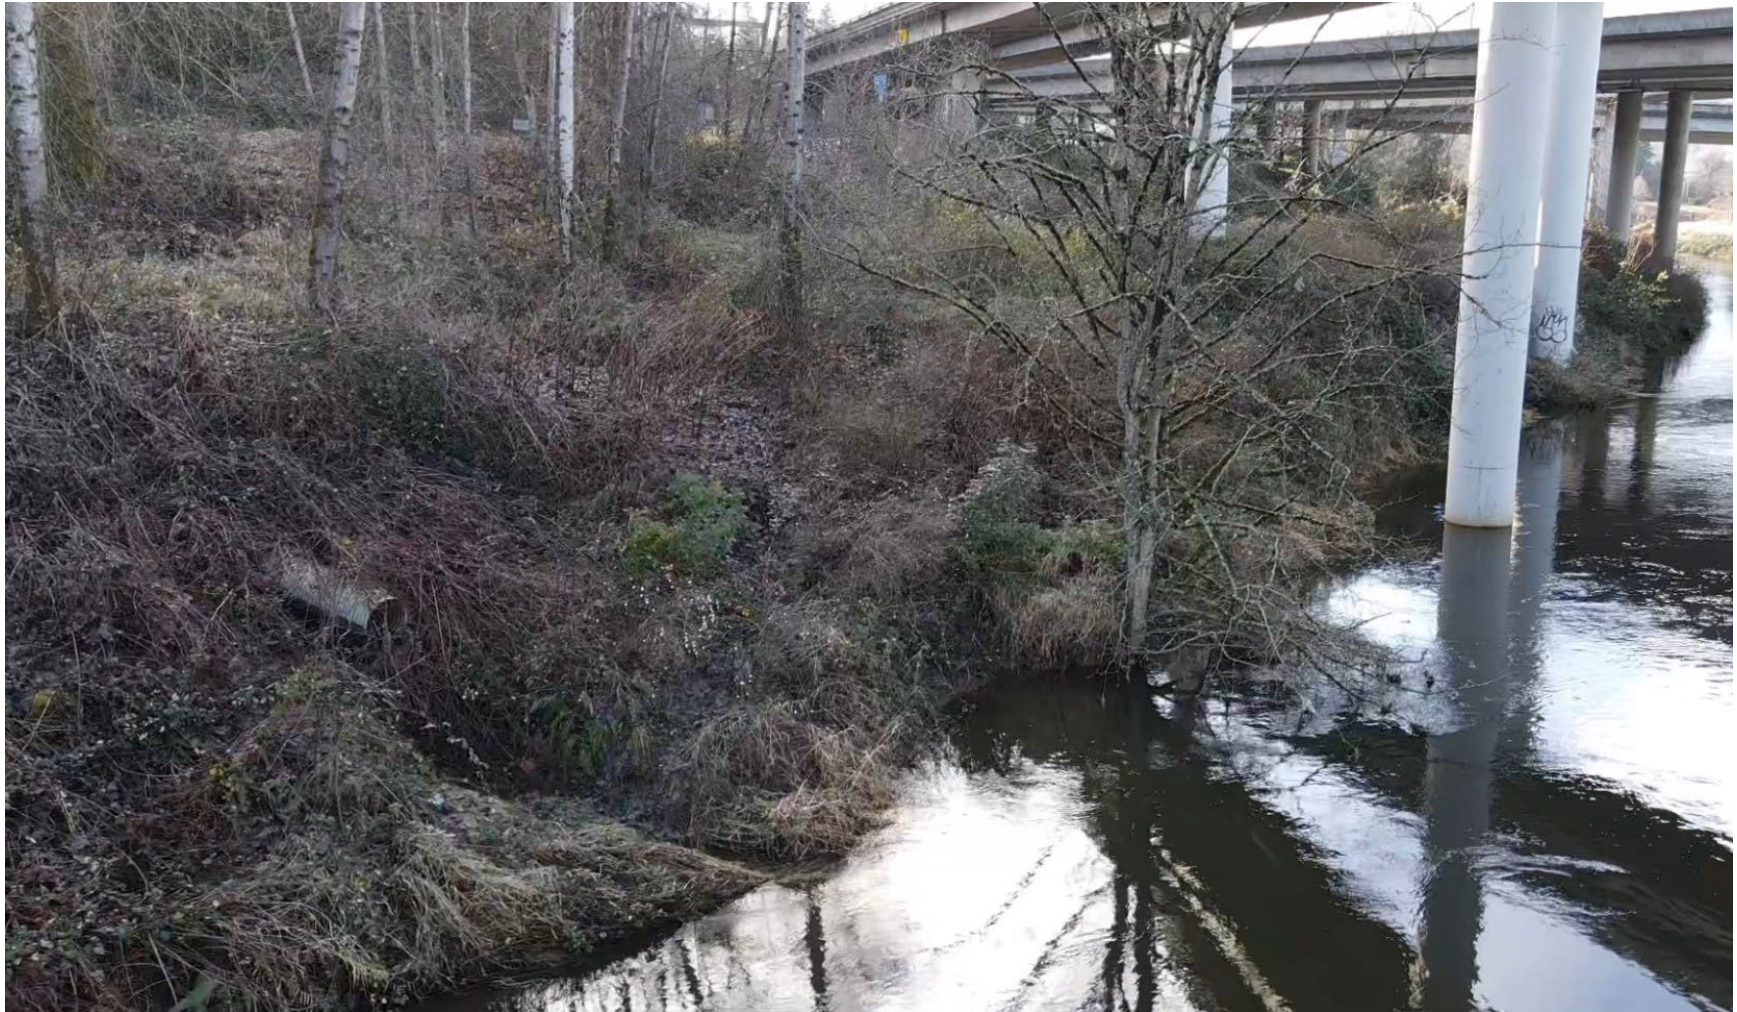
Figure 6. Photo of the Sammamish River looking west through along the south bank. Note the projecting pipe and bank scour around the existing NB I-405 ramp column (January 1, 2023 site visit).
