DRAFT WETLAND AND STREAM ASSESSMENT REPORT

I-405, Brickyard Inline Transit Station Project

**Prepared by
I-405/SR 167 Megaprogram**

February 2021

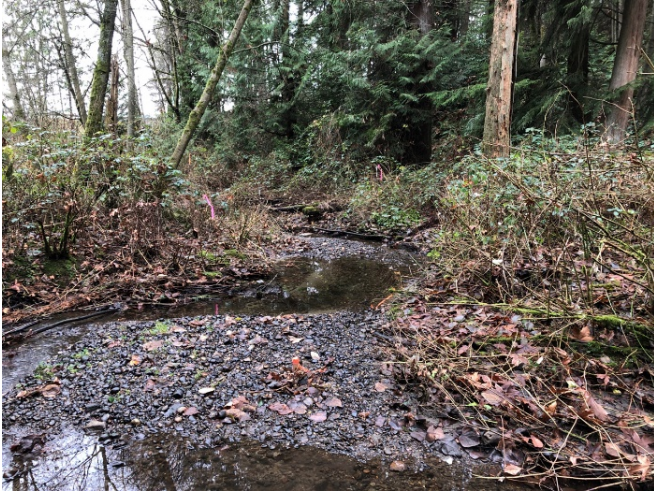
Table 3. Wetland 21.94R Summary

WETLAND 21.94R – INFORMATION SUMMARY		
Location	Along Juanita Creek, east of I-405, southwest of NE 148th Place

Local Jurisdiction	City of Kirkland
	WRIA	8
	Ecology Rating (Hruby 2004)	Category III
	City of Kirkland Rating (KZC 905.55.1)	Category III
	City of Kirkland Buffer Width	105 feet
	Wetland Size in Study Area	0.30 acre
	Cowardin Classification	PSS/PFO
	HGM Classification	Riverine
	Wetland Data Sheet(s)	SP 21.94R-WET1 and SP 21.94R-WET2
	Upland Data Sheet(s)	SP 21.94R-UP1 and SP 21.94R-UP2
Flag Color	Pink	
Dominant Vegetation	Wetland 21.94R is composed of a forested and scrub-shrub vegetation community that consists of red alder (<i>Alnus rubra</i>) with an understory of salmonberry (<i>Rubus spectabilis</i>), Himalayan blackberry (<i>Rubus armeniacus</i>), red-osier dogwood (<i>Cornus sericea</i>), slough sedge (<i>Carex obnupta</i>), lady fern (<i>Athyrium felix-femina</i>), twinberry (<i>Lonicera involucrate</i>), climbing nightshade (<i>Solanum dulcamara</i>), and soft rush (<i>Juncus effusus</i>). This wetland is also dominated by a scrub-shrub vegetation community consisting primarily of salmonberry and Himalayan blackberry. Vegetation meets the prevalence index and dominance test for hydrophytic vegetation.

Soils	Observed soils in Wetland 21.94R consist of 8 inches of very dark grayish brown (10YR 3/2) sandy loam over 12 inches of very dark gray (10YR3/1) sandy loam or 12 inches of very dark grayish brown (2.5Y 3/2) sandy loam with redoximorphic features over 6 inches of dark gray (5Y 4/1) loamy sand with redoximorphic features. Soils in Wetland 21.94R meet the hydric soil indicators for Hydrogen Sulfide (A4) and a Redox Dark Surface (F6).	
Hydrology	At the sample plot locations, soils were saturated to the surface and a water table was present within 12 inches from the surface. Primary sources of hydrology include a high groundwater table and overbank flooding from Juanita Creek.	
Rationale for Delineation	All three wetland criteria are present. The boundaries of Wetland 21.94R were determined by change in vegetation and soils and were flagged where indicators of wetland vegetation, hydric soil, and wetland hydrology were present.

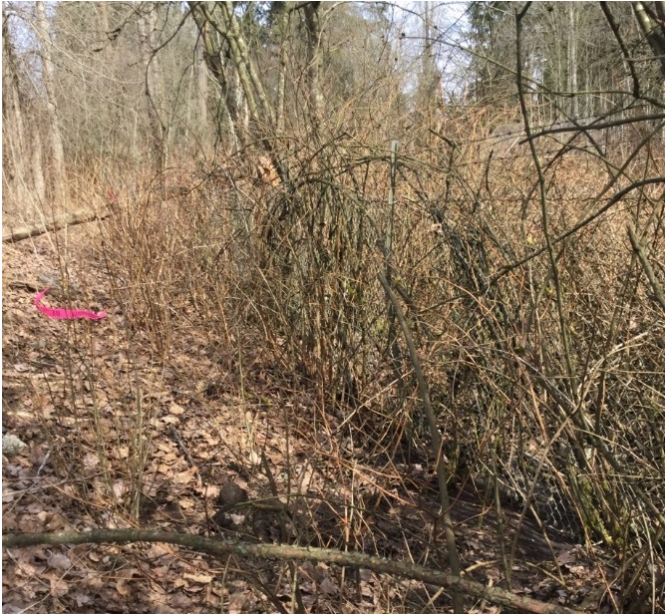
Table 4. Wetland 22.11R Summary

WETLAND 22.11R – INFORMATION SUMMARY		
Location	North of Juanita Creek, west of 116th Place NE, east of I-405

Local Jurisdiction	City of Kirkland
	WRIA	8
	Ecology Rating (Hruby 2004)	Category III
	City of Kirkland Rating (KZC 905.55.1)	Category III
	City of Kirkland Buffer Width	60 feet
	Wetland Size in Study Area	0.00 acre
	Cowardin Classification	PSS
	HGM Classification	Depressional
	Wetland Data Sheet(s)	SP 22.11R-WET
	Upland Data Sheet(s)	SP 22.11R-UP
Flag Color	Pink	
Dominant Vegetation	Wetland 22.11R is dominated by a scrub-shrub vegetation community consisting of salmonberry, red alder and black cottonwood saplings, and Himalayan blackberry. Vegetation meets the prevalence index and dominance test for hydrophytic vegetation.	
Soils	Soils in Wetland 22.11R consist of 14 inches of black (10YR 2/1) silt loam and 4 inches of grayish brown (2.5Y 5/2) loamy sand with redoximorphic features. This sample plot was located at the edge of the wetland as the majority of the wetland is located outside of the WSDOT right of way. With the presence of hydrophytic vegetation and hydrology, the sample plot is assumed to have a continued depleted matrix below 18 inches and assumed to meet the hydric soil indicator for Thick Dark Surface (A12).

Hydrology	Soils were saturated to 6 inches below the soil surface, and a water table was present at 14 inches in the soil pit. The primary source of hydrology is a high groundwater table.	
Rationale for Delineation	All three wetland criteria are present. The boundaries of Wetland 22.11R were determined by change in vegetation and soils and were flagged where indicators of wetland vegetation, hydric soil, and wetland hydrology were present.	
Rationale for Local Rating	Wetland 22.11R is rated Category III with a score of 7 for water quality, 6 for hydrologic functions, and 3 for habitat functions, scoring 16 points on the wetland rating form.	
Wetland Functions Summary		
Water Quality	Wetland 22.11R has moderate site potential to improve water quality because the wetland is a depression with no outlet and greater than half of the wetland has persistent, ungrazed plants. The wetland has a moderate landscape potential to improve water quality because it receives stormwater discharge and greater than 10 percent of the area within 150 feet of the wetland is in land uses that generate pollutants. Wetland 22.11R has high water quality value because it is located in a basin with resources on the 303(d) list and a Total Maximum Daily Load.

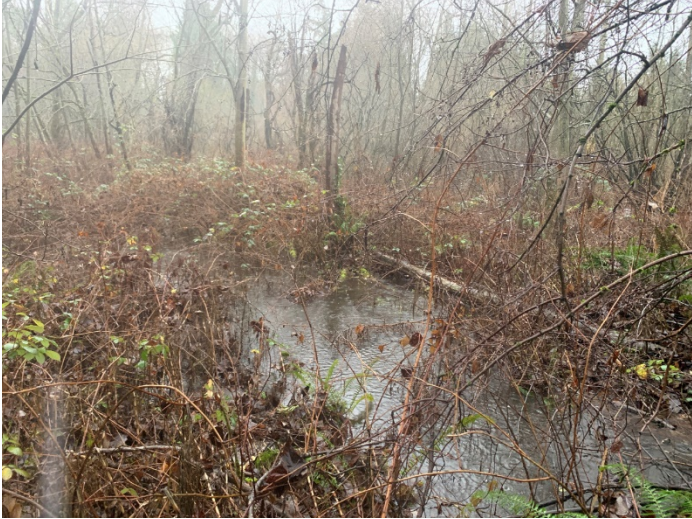
Table 5. Wetland 22.24L Summary

WETLAND 22.24L – INFORMATION SUMMARY		
Location	West of I-405 at MP 22.24, east of Juanita Woodinville Way NE

Local Jurisdiction	City of Bothell
	WRIA	8
	Ecology Rating (Hruby 2004)	Category III
	City of Kirkland Rating (KZC 905.55.1)	Category III
	City of Kirkland Buffer Width	75 feet
	Wetland Size in the Study Area	0.15 acre
	Cowardin Classification	PSS/PFO
	HGM Classification	Depressional
	Wetland Data Sheet(s)	SP 22.24L-WET
	Upland Data Sheet (s)	SP 22.24L-UP
	Flag Color	Pink
Dominant Vegetation	Wetland 22.24L consists of a scrub-shrub and forested community that is dominated by red alder, black cottonwood, Sitka willow (<i>Salix sitchensis</i>), salmonberry, and Himalayan blackberry. Vegetation meets the prevalence index and dominance test for hydrophytic vegetation. A portion of the wetland in the study area was created by King County as a wetland mitigation site in 2008.	
Soils	Soils in Wetland 22.24L consist of 7 inches of brown (10YR 4/3) loamy sand over 11 inches of dark grayish brown (10YR 4/2) loamy sand with redoximorphic features. Soils at Wetland 22.24L meet the hydric soil indicator for a Depleted Matrix (F3).

Hydrology	Stream 22.25L flows through Wetland 22.24L but the primary source of hydrology is a high groundwater table. Hydrology indicators observed include saturation at 7 inches. A water table was observed at 12 inches below the soil surface.	
Rationale for Delineation	All three wetland criteria are present. The boundaries of Wetland 22.24L were determined by a topographic break and were flagged where indicators of wetland vegetation, hydric soil, and wetland hydrology were present.	
Rationale for Local Rating	Wetland 22.24L is rated Category III with a score of 7 for water quality, 6 for hydrologic functions, and 5 for habitat functions, scoring 18 points on the wetland rating form.	
Wetland Functions Summary		
Water Quality	Wetland 22.24L has moderate site potential to improve water quality because it has an intermittently flowing stream (Stream 22.25L) flowing through it and greater than 50 percent of the wetland area has persistent, ungrazed plants. It has moderate landscape potential because the wetland receives stormwater discharge and greater than 10 percent of the area within 150 feet of the wetland is in land uses that generate pollutants. It has a high value for water quality treatment as it discharges (within 1 mile) to Juanita Creek, which on the 303(d) list.

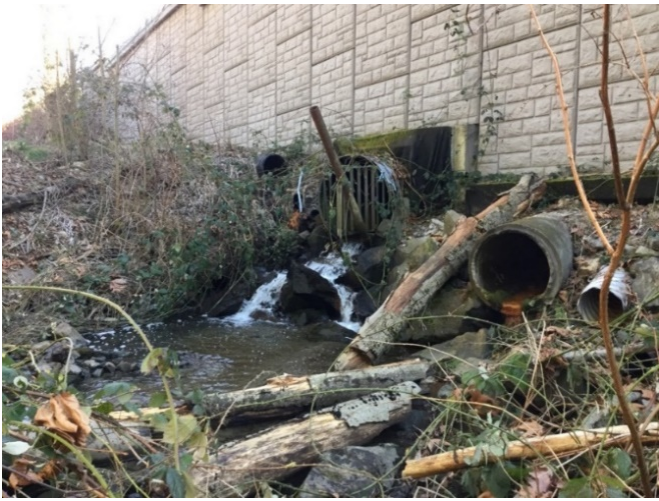
Table 7. Stream Information Summary—Juanita Creek

Stream Name Juanita Creek
	WRIA 8
	WA Stream Catalog No. 08-0230
	Local Jurisdiction City of Kirkland
	Local Stream Rating Type F
	Buffer Width 100 feet
	Documented Anadromous Fish Use Coho, sockeye, fall Chinook, winter steelhead (SalmonScape)
Location of Stream Relative to Project Corridor	Juanita Creek crosses I-405 from east to west at milepost (MP) 21.94 through a 48-inch culvert.
Connectivity (where stream flows from/to)	Juanita Creek originates in a neighborhood east of I-405 just south of East Norway Hill Park. It generally flows southwest through an open channel until it reaches I-405. The creek is conveyed in pipes until it outlets at 119th Avenue NE. Just downstream of 119th Ave NE, the creek outlets into a forested valley and flows in a well-defined channel that has moderate to good floodplain connectivity. The creek enters the culvert under I-405 and then outlets downstream of I-405 through a 48-inch concrete pipe. From there, the creek flows through a series of open channels and culverts until it reaches Lake Washington.

Riparian/Buffer Condition	Upstream of the I-405 crossing, Juanita Creek flows through a mixed forest area that contains bigleaf maple (<i>Acer macrophyllum</i>), western red cedar (<i>Thuja plicata</i>), and Douglas-fir (<i>Pseudotsuga menziesii</i>), and flows into a 48-inch-wide culvert. Downstream of I-405, Juanita Creek flows through a residential neighborhood, and the riparian vegetation along the stream is dominated by red alder (<i>Alnus rubra</i>), Pacific willow (<i>Salix lucida lasiandra</i>), and Himalayan blackberry (<i>Rubus armeniacus</i>).

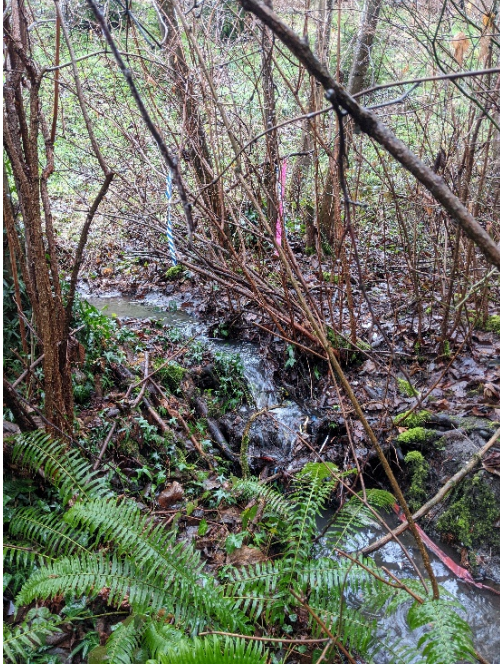
Table 8. Stream Information Summary—Stream 22.25L

<table><tr> <td>Stream Name</td> <td>Stream 22.25L</td> </tr></table>

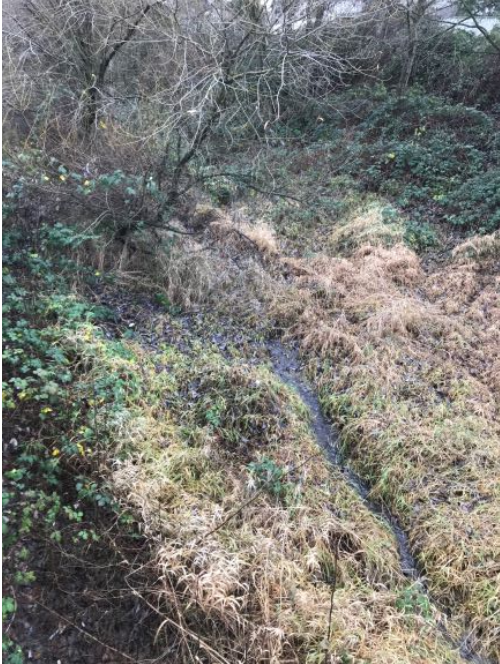
Table 9. Stream Information Summary—Stream KL14

<table><tr> <td>Stream Name</td> <td>Stream KL14</td> </tr></table>

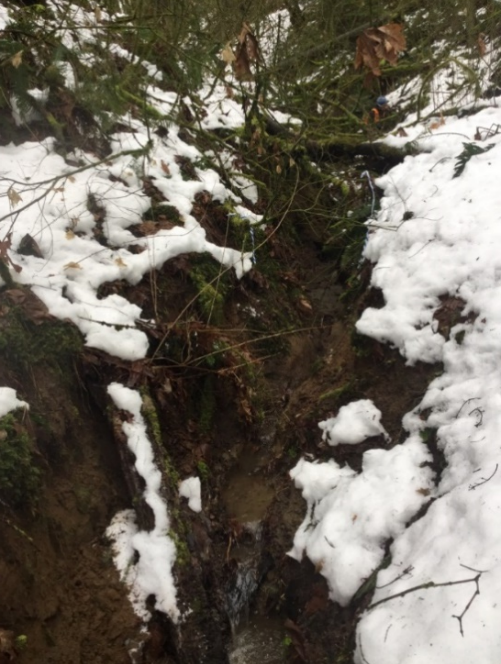
Table 10. Stream Information Summary—Stream 42

<table><tr> <td>Stream Name</td> <td>Stream 42</td> </tr></table>
